WEYERHAEUSER REBUILD OF BARK FEED SYSTEM CUTS POWER BOILER DOWNTIME

Solving problems such as pitch variance, product variance, and stress corrosion cracking in screw feeder system reduces maintenance costs

By JOHN ALMAREZ

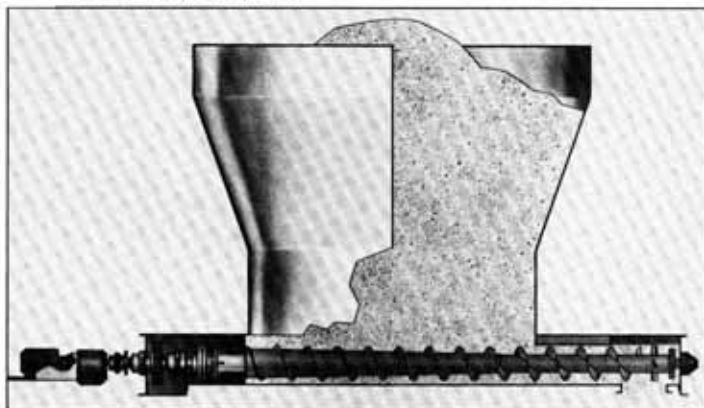
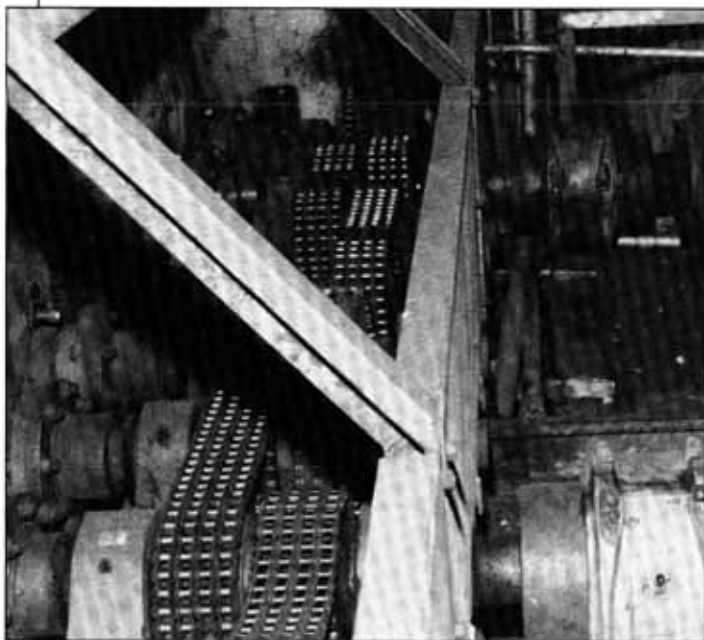
FIGURE 1: Martin Sprocket & Gear Inc.'s live-bottom bin arrangement eliminated system malfunctions and breakdown at the Valliant, Okla., mill.

Variable thrust caused misalignment in the sprocket drivetrain and caused roller chain and sprocket failures. A cone screw design was used to eliminate variable thrust, which helped reduce premature roller chain and sprocket failures.
