Diagnosing common gear-drive problems

David Kennedy Martin Sprocket & Gear Inc.

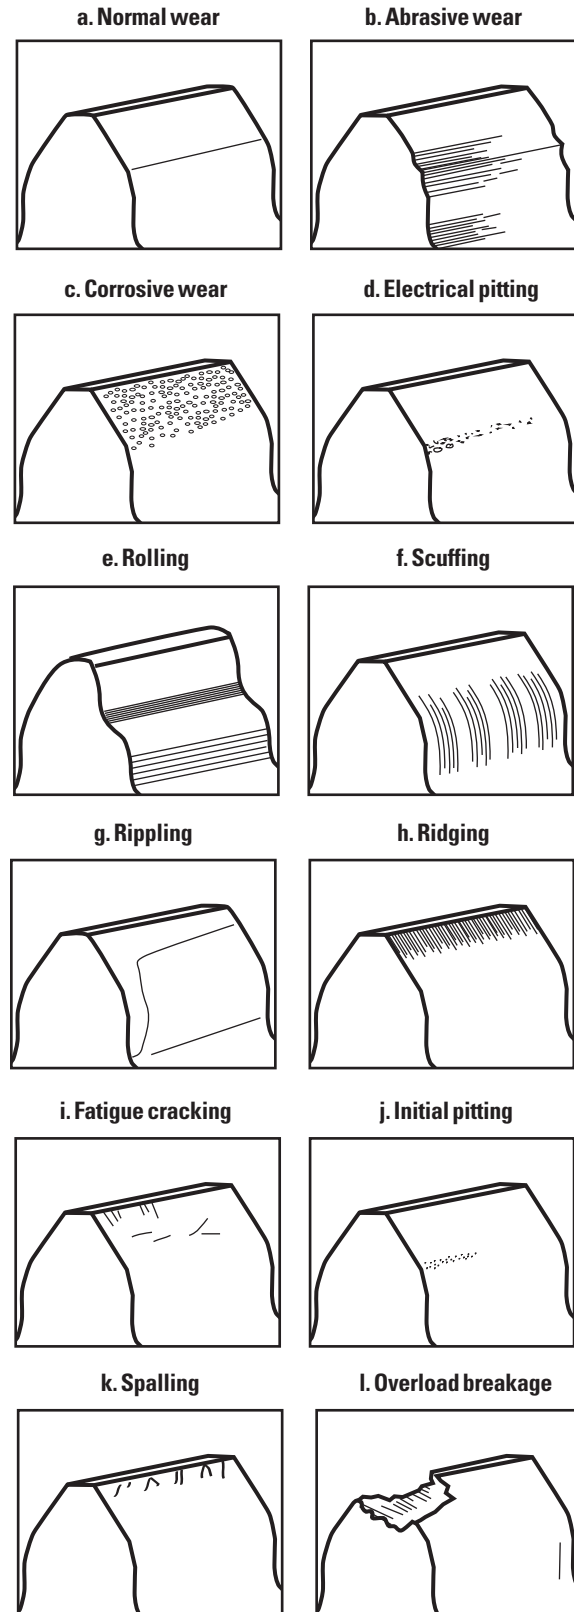
Figure 1

Gear wear patterns

Abrasive wear. Abrasive wear, as shown in Figure 1b, is often caused by small, hard particles from worn gear teeth or the surrounding environment contaminating the gear drive's lubricating oil. These particles scratch the gear teeth as the gears engage each other during operation. Maintaining clean, particle-free lubricating oil can help prevent abrasive wear. Follow these steps to remove abrasive contaminants from your gear drive's lubricating oil:

Corrosive wear. Corrosive wear, as shown in Figure 1c, occurs when acid comes into contact with the gear teeth, causing a chemical reaction with the metal. Corrosive wear is usually identified by a stained or rusty appearance on the gear surface and can be caused by system overload or improper maintenance procedures. If your gear drive is showing corrosive wear, check with the drive supplier for the recommended maintenance procedures and lubricant type. You may need to perform more frequent oil changes or upgrade to an extreme-pressure lubricant. If the system is overloaded, you'll need to either reduce the load or upgrade the drive.

Electrical pitting. Electrical pitting, as shown in Figure 1d, can occur when electric discharges arc across the film of oil between mating gear teeth, causing small indentations to form on the tooth surface. These electric discharges can be caused by improper electrical system installation and grounding or static electricity generated by the conveying process. If your process is generating static electricity, install grounding straps from the conveyor to rigid electrical or pneumatic piping to dissipate the electrostatic charge. Also, when welding in the area, be sure to place the ground clamp so that the current doesn't flow through the gear drive and arc between the gear teeth.

Rolling and scuffing. Rolling (also called peening), as shown in Figure 1e, is the deformation of metal on the active portion of the gear tooth caused by high-contact stresses. This displacement of surface material creates horizontal grooves along the tooth face and causes burrs to form at the gear tooth's tip.

Scuffing is severe abrasion that causes metal from one gear tooth surface to transfer to another tooth due to welding and tearing action during operation. Scuffing can be identified by vertical lines on the tooth surface, as shown in Figure 1f. Scuffing is generally localized in patches where the meshed tooth surfaces are mismatched or misaligned.

Plastic flow failure. Plastic flow failure (also called rippling or ridging), as shown in Figures 1g and 1h, is a type of deformation of the gear-tooth surface caused by high levels of sliding or rolling stress between mating gear teeth. Plastic flow failure typically affects gears made of softer metals but can also occur in case-hardened gears. Heavily loaded worm drives and hypoid-and-pinion gear drives, which combine high compressive stress with high-contact, low-velocity sliding action, are most-frequently affected. Plastic flow failure is typically caused by improper lubrication or excessive operating loads and can become dangerous in advanced stages.

Uneven gear-tooth surfaces or shock loads can create local areas of high stress at the gear-tooth surface. This can lead to surface fatigue failures such as initial pitting, as shown in Figure 1j, and spalling, as shown in Figure 1k. Spalling is similar to pitting, but material continues to break away from the edges of the pits, forming large, irregular, interconnected voids in the tooth surface.

Gear-tooth breakage. Premature gear-tooth breakage, as shown in Figure 1l, can be caused by contaminants entering the gear drive, overload, or shock load. If outside contamination has caused the breakage, remove the contamination and cover the drive to prevent further damage. If the breakage was caused by overload or shock load and eliminating the overload or shock load condition isn't possible, consider upgrading the drive. You can replace the drive with one that uses wider-faced gears or, if your drive's gears use a 14.5-degree pressure angle, switch to a drive with gears that use a 20-degree pressure
